SOME TIPS ABOUT THE CLASSIFICATION OF WIRE BREAKAGES – PART B

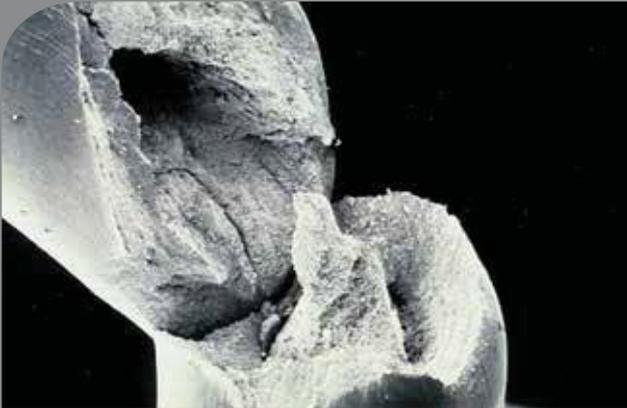
Figure 1 – Typical cuppy wire break

Central bursting, oftentimes referred to as “cuppy” wire, is associated with a brittle type of fracture that has both a cup (or hole) end and a mating cone end. A typical cuppy wire break is shown in **Figure 1**. Cuppy wire is classified as drawing related because it is caused by poor die geometry, such as a very low reduction in area or a large reduction zone die angle. A schematic curve illustrating the relationship between reduction in area during wire drawing and the corresponding die semi cone angle is shown graphically in **Figure 2** with friction being a variable process parameter. No central burst is expected above or to the left of the frictional curve. However, one should anticipate central bursting to occur both below and to the right of the appropriate curve. The danger zone usually becomes smaller as the coefficient of strain hardening becomes larger. A very small area reduction at any die causes the surface of the wire to move at a faster velocity than its center, and consequently introduces a high tensile stress at the center of the wire. When this stress becomes large enough, the fracture stress of the wire may be exceeded, which will nucleate a crack. As wire drawing proceeds, the crack gradually propagates on a 45 degree shear plane with respect to the drawing direction, and eventually results in a cup and cone type of fracture with the cone end pointing in the direction of wire drawing. **Figure 3** is a metallographically prepared cross-section of a copper wire that has been taken at its center soon after the initiation of central bursting. Since copper is quite ductile, complete separation does not usually occur until the wire has been drawn through many dies. In fact, if the crack initiates within the rod breakdown machine but does not progress sufficiently to induce fracture by the last die, the process wire may break in the secondary wire drawing machine or later. However, since the direction of drawing is now reversed, any internal V-shaped crack will point in the opposite direction of wire drawing, and the resulting cup end of the break that is left in the machine will now point in the wire drawing direction. If conditions for central bursting are prevalent in both the rod breakdown machine and the subsequent secondary wire drawing machine, V-shaped cracks will point in both directions. This is illustrated by the photomicrograph in **Figure 4**. Cups occur in the center of the wire and look almost identical to that of macroporosity (hollow end) breaks and similar to some inclusion absent and ductile tensile breaks. Consequently, it is oftentimes very difficult to make a distinction between cups and macroporosity breaks, even though there is less reduction in area at the cup end.

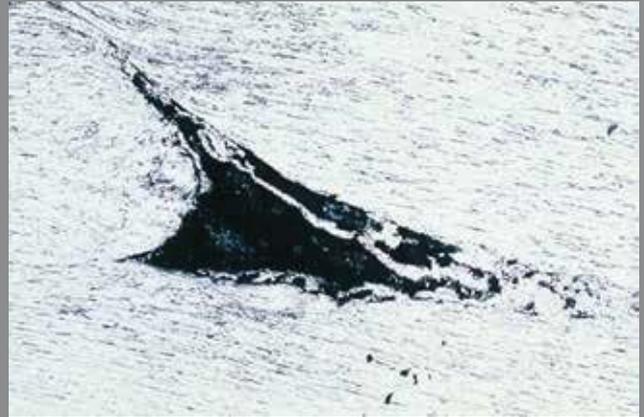
Figure 3 – Metallographically prepared cross-section of a copper wire
